WATTS BAR NUCLEAR PLANT (WBN) UNIT 1 - NRC ORDER EA-03-009 -
INTERIM INSPECTION REQUIREMENTS FOR REACTOR PRESSURE VESSEL
HEADS (TAC NO. MB 7667) AND BULLETIN 2003-02 - LEAKAGE FROM
REACTOR PRESSURE VESSEL LOWER HEAD PENETRATIONS AND REACTOR
COOLANT PRESSURE BOUNDARY INTEGRITY (TAC NO. MC 0576)

WATTS BAR NUCLEAR PLANT UNIT 1
NRC ORDER EA-03-009 AND BULLETIN 2003-02
REACTOR PRESSURE VESSEL CLOSURE HEAD AND LOWER HEAD INSPECTION
REPORT NO. R0922 CYCLE 5 EXCERPTS

**Watts Bar Unit 1, Cycle 5 – RPV Closure Head REPORT
Remote Visual (VT-2) Penetration Examination Final Report**

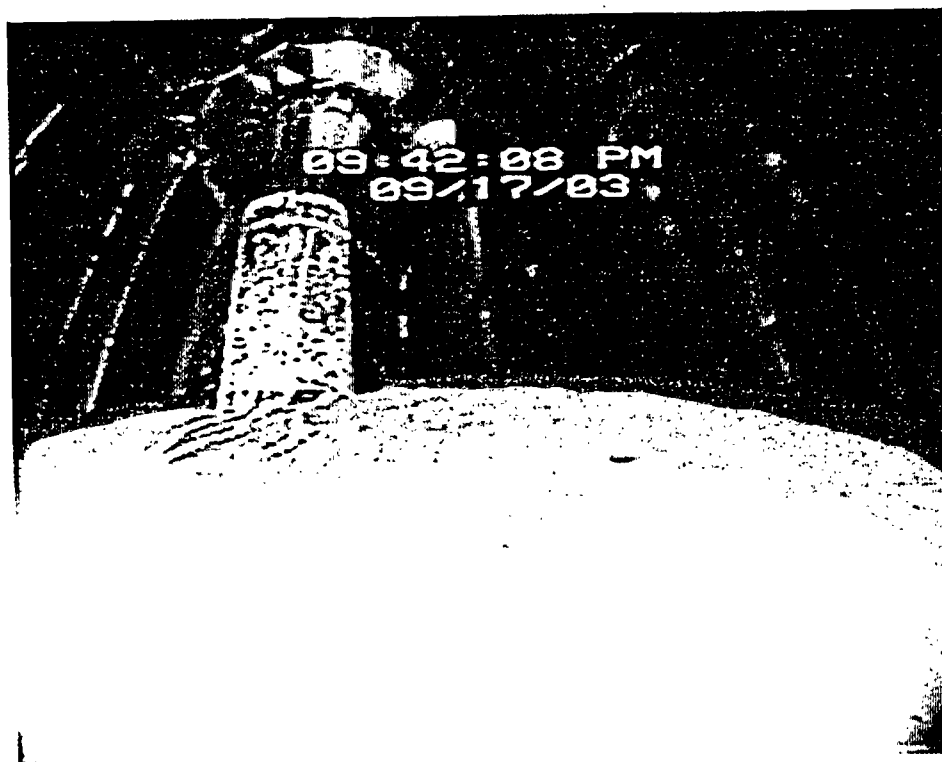
Figure 2: Penetration 60, Scan 20. As found boron deposit

Reactor Head Inspection has been completed with one CRDM penetration requiring further evaluation. There was evidence of boron residue on CRDM Penetration #60 below the insulation and on the peripheral CRDM area. PER 03-016293-000 was initiated to document this condition.

WO 03-016329-000 was issued to clean the penetration and the adjacent head area and the penetration was examined by liquid penetrant (N-PT-9) examination on 9/19/03. The head was cleaned and the examination identified no relevant or non-relevant indications. It has been noted that a canopy seal weld leak on this CRDM was identified during RFO1 and was repaired under WO 97-013542-001.

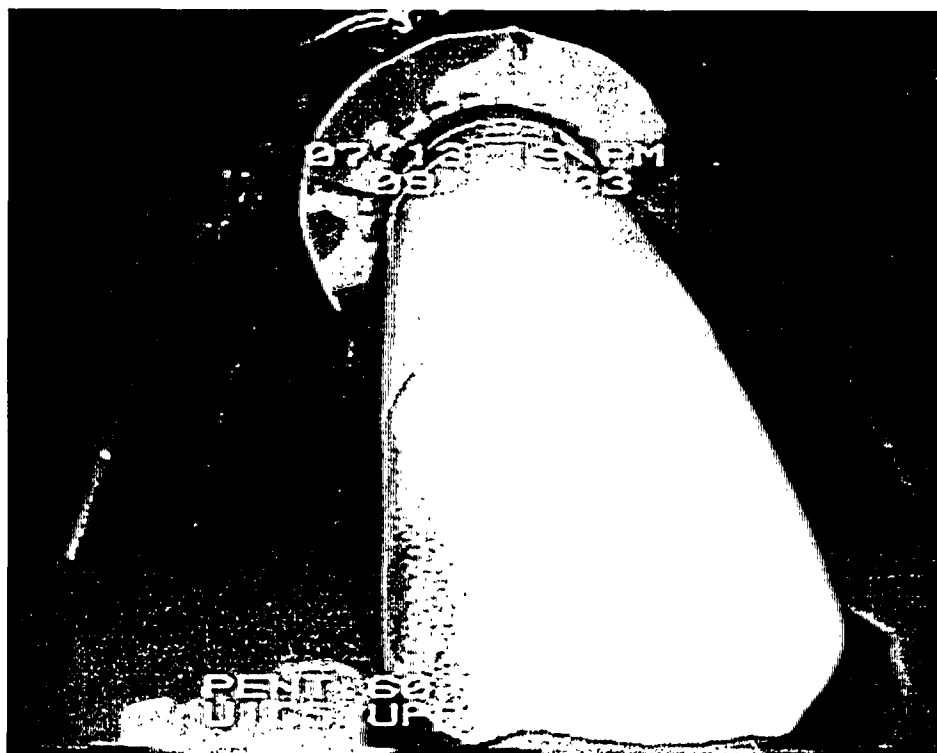
Figure 6: Penetration 60. PT exam, interpretation step.

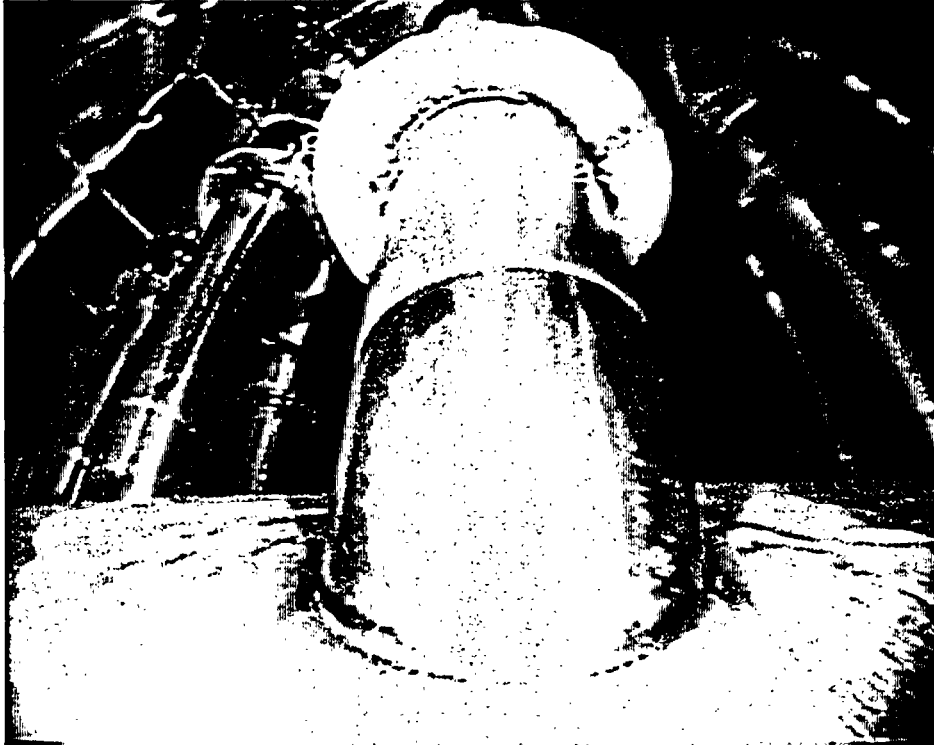
Figure 7: Penetration 60, cleaning after PT exam.

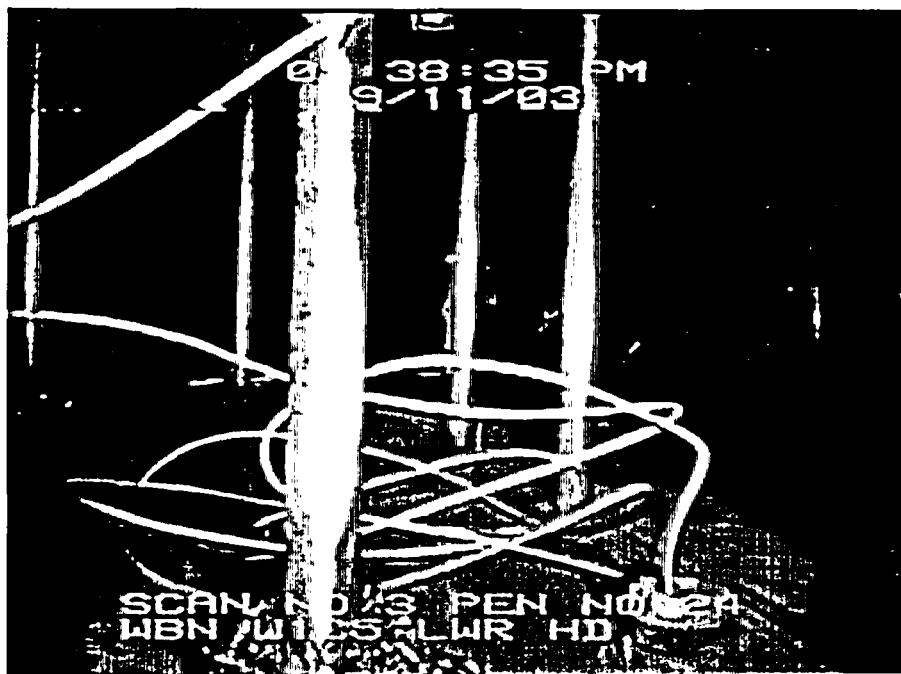
Another observation was the "loose parts monitoring" instrument wiring seen at penetrations 24 and 38. The wiring at penetration 24 was loosely bundled and was an obstacle for the crawler. The wiring at penetration 38 was installed tightly against the surfaces and was not an obstacle. It is suggested that an evaluation be made to readjust the material at penetration 24 to prevent a possible obstruction for future exams. WBN Work order # 03-016028-000 was written to address this condition.
Ref: Section 4: Figure 6

**FIG. 6: INSTRUMENTATION WIRING OBSTACLE IN SCAN PATH AT
PENETRATION 24**

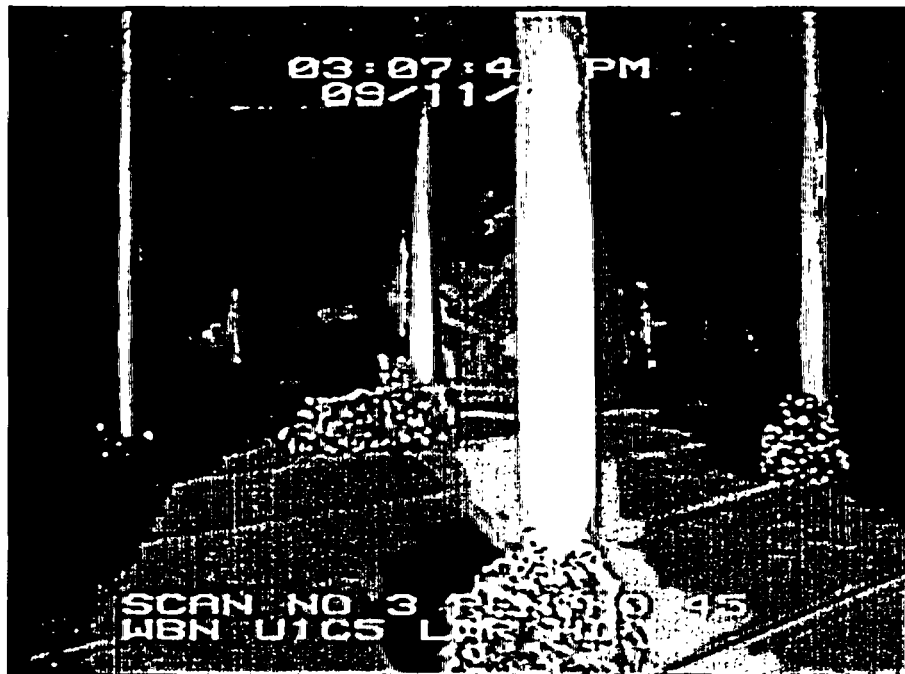
A spun steel material was observed at the majority of the intersections formed by the insulation to BMI tubing. This material was also seen lying loose on the insulation surface. Although it did not present an obstruction, the material itself was a concern and did become entangled in the crawler tracks on three occasions. The material was removed by remote manipulation of the crawler. It is suggested that an evaluation be made to remove this material to prevent possible damage to the remote device. This action would present an opportunity to lessen dose (if manual retrieval was required), lessen outage schedule impact resulting from repair delays and could be a cost savings if replacement equipment was purchased.

FIG.7: SPUN STEEL MATERIAL AT INSULATION/TUBING JOINTS

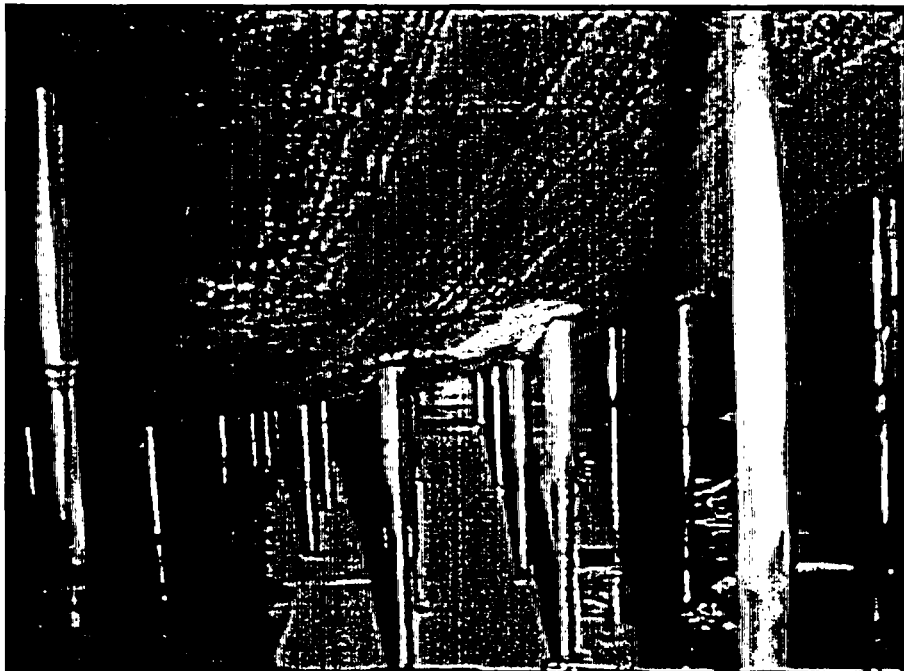
On nearly all exams, light to moderate staining and surface rust was seen around the annular area and on the bare head surface. These areas had trails from above the bottom head. The condition was not associated with boron leakage from the BMI penetrations. Ref: Section 4: Figures 2, 3, 5, 8, and 9.

**FIG.8: GENERAL VIEW OF BARE HEAD CONDITION FROM PEDESTAL
CAMERA**

The subject PER documents the presence of rust on the surface of the reactor vessel lower head. This rust was photographed during the remote inspection that was performed on the bottom mounted penetrations. This rust was believed to be tightly adhering, light surface rust based on the photos and video taken during the inspection. A subsequent inspection was performed on 10/12/2003 by Modifications and Design Engineering personnel to determine the extent of the rust on the surface of the lower head.

Two areas, approximately 6" X 6", were selected for cleaning and review. One of the two areas selected contained rust colorations consistent with the majority of the lower head, while the other area was selected because the rust colorations looked heavier in that location. The inspection involved wiping the surface with a damp cloth, removing the substance with a lightly wetted pad of Scotchbrite, and wiping the area a final time with a damp cloth. The two areas cleaned up with minimal effort, and were wiped down to expose the surface of the head. The surface of the lower head was observed to be smooth after cleaning the two areas. The substance was mostly removed during the initial wipe down with the damp cloth. The substance on the lower head is believed to be a combination of light rust and what remains of an initial protective coating. Based upon the ease of removal of the substance, it is determined that there is very little rust on the vessel lower head itself. The substance left a brownish-black, thick residue on the cloth after wiping, which led to the conclusion that there was some of the initial protective coating present. Both areas contained only light rust, and these areas are considered to be representative of the condition on the lower head. This observation is consistent with the determination made during the ROV inspection at the start of the outage. Therefore, no further corrective action will be required.
